saving history

a Garcia Street home's second chance

by Lexi Marshall
photographs by Daniel Nadelbach

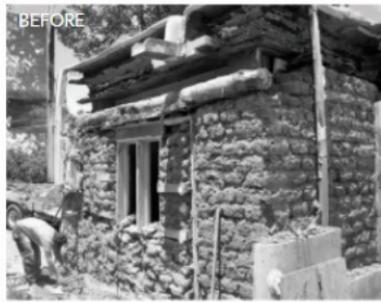
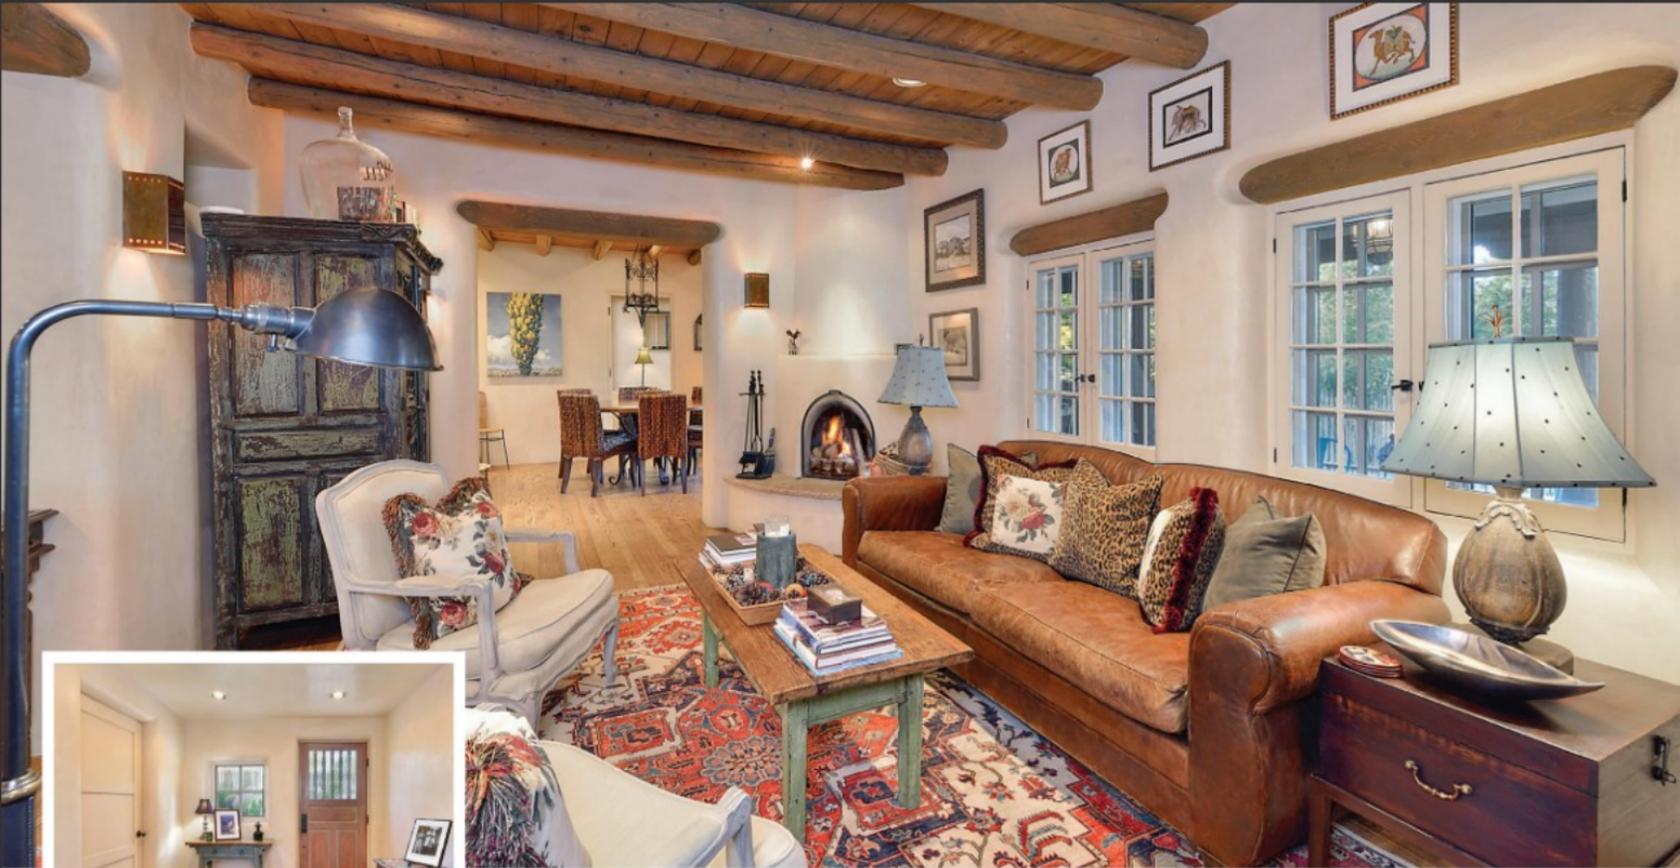
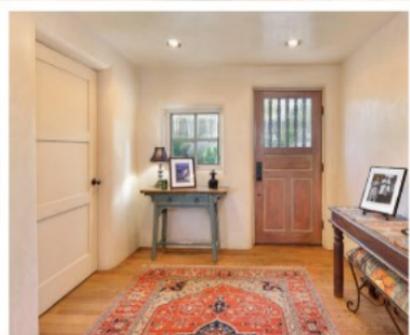
BEFORE

Reclaimed oak flooring, over a century old, was refinished and reinstalled after the entire floor system was removed to replace rotting joists. Nearly all original vigas were salvaged despite extensive structural repairs.

What followed was a two-year forensic investigation that revealed a sobering truth: "The structural integrity of the adobe that was not redone—it was covered up—was failing drastically," recalls builder Bill Deuschle of Fabuwallous Solutions. During one inspection, he opened a parapet wall and watched adobe pour out like loose sand. "I had time to grab two five-gallon buckets and put them under it, and it filled them up."

The diagnosis was grim: The entire south and west elevations needed to be removed down to grade, requiring new footings and foundations. The Santa Fe

held remaining walls together with steel rods while systematically deconstructing the failing sections. Floors came out. Joists—many of which had been covered with dirt and were rotting—were removed.

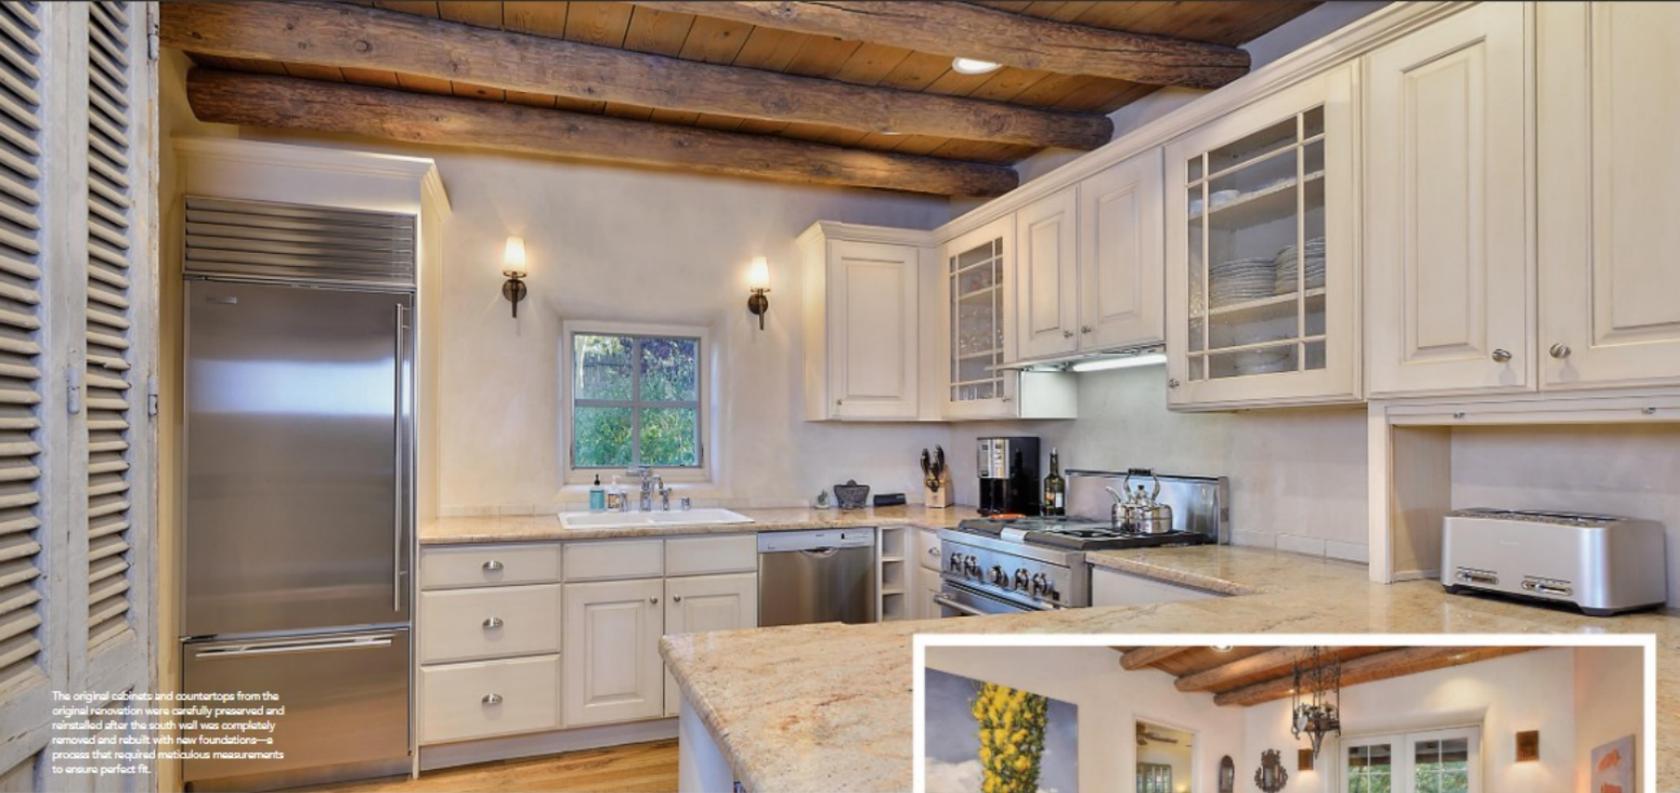
The original cabinetry and countertop from the original renovation were carefully preserved and reinstalled after the south wall was completely removed and rebuilt with new foundations—a process that required meticulous measurements to ensure perfect fit.

Throughout the process, measurements became critical. "I've never taken so many measurements on a house in my life," Deuschle admits. The precision paid off—cabinets and countertops were saved and reinstalled, reclaimed century-old oak flooring was refinished, and the exterior was restored to appear untouched.

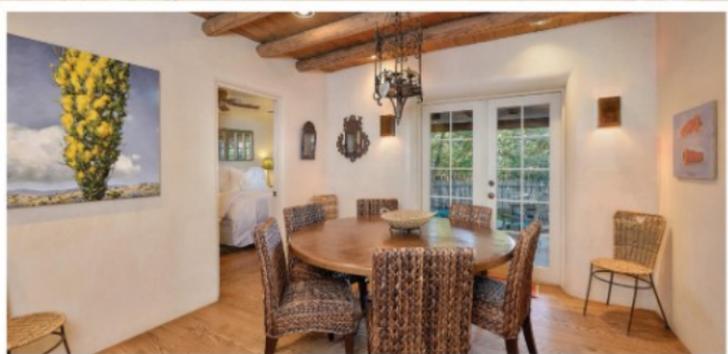
Historic windows function as interior shutters while modern double-paned thermal windows provide 21st-century energy efficiency. This innovative solution satisfied preservation requirements while dramatically improving comfort.

The 14-inch-thick adobe walls also inspired an innovative solution for the windows. Historic preservation rules prohibited removing the original windows, so Deuschle proposed using them as interior shutters while installing modern, double-paned thermal windows that matched the historic profiles exactly. "Historic loved the idea," he notes. The result: 21st-century energy efficiency wrapped in authentic period character.

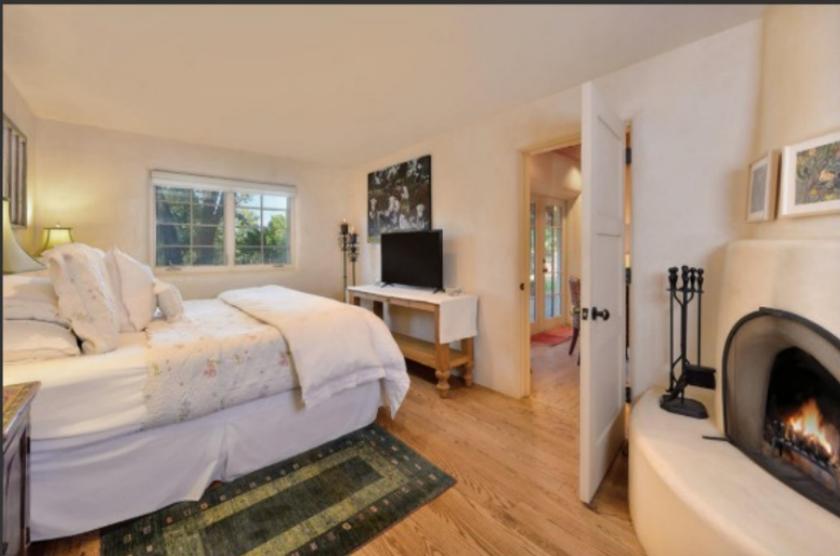
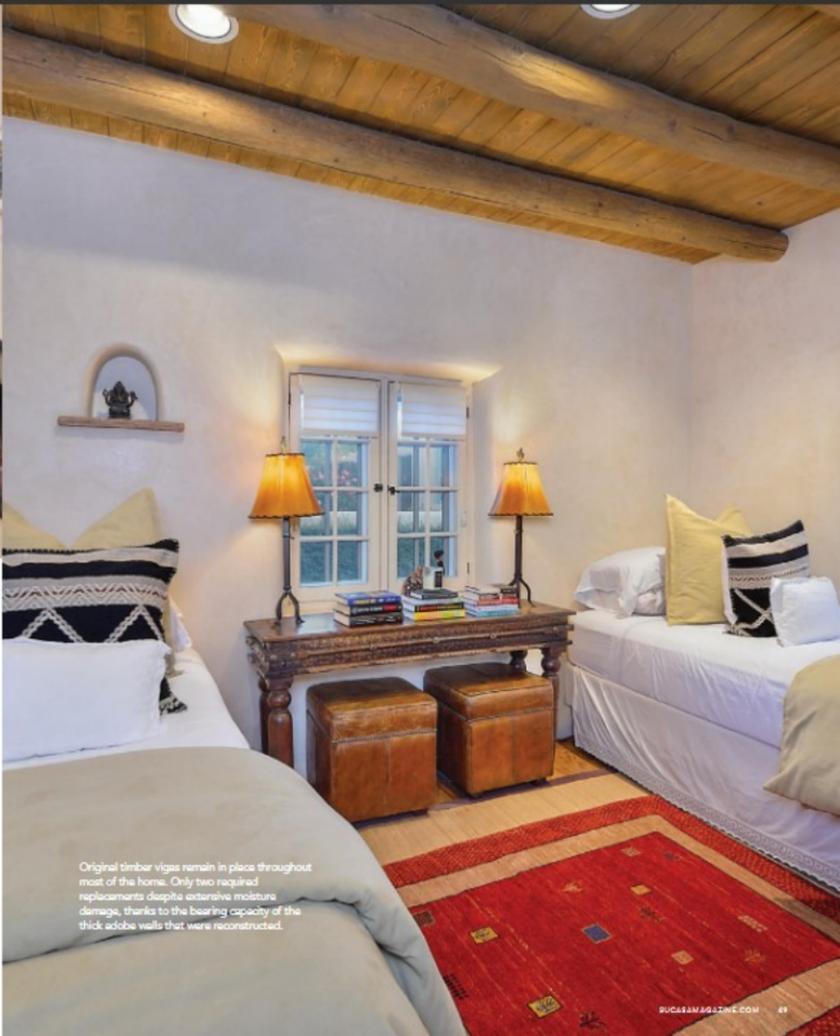
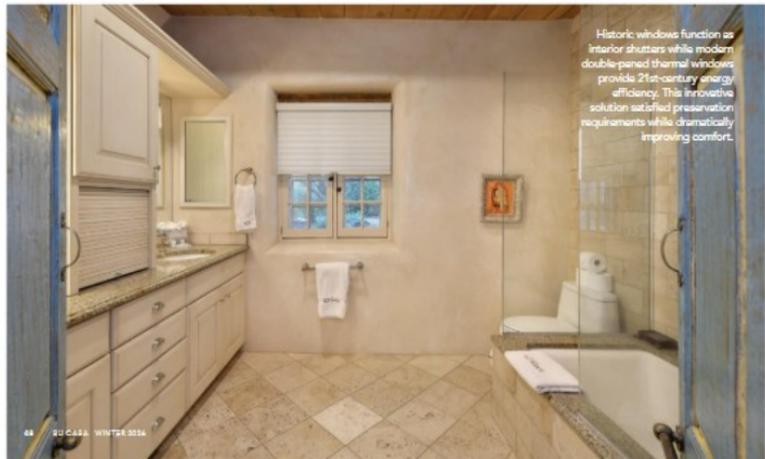
Original timber vigas remain in place throughout most of the home. Only two required replacements despite extensive moisture damage, thanks to the bearing capacity of the thick adobe walls that were reconstructed.

Yet amid the destruction, there were surprising victories. While hundreds of joists needed replacement under the new flooring, only two vigas required replacing in the adobe walls. The thick walls provided enough bearing that nearly all the historic timber could be salvaged—a detail that delighted the HDRB.

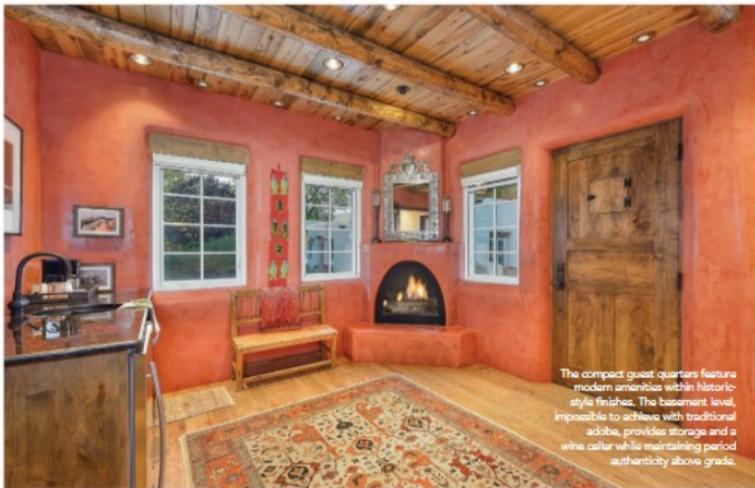
The compact guest quarters feature modern amenities within historic-style finishes. The basement level, impossible to achieve with traditional adobe, provides storage and a wine cellar while maintaining period authenticity above grade.

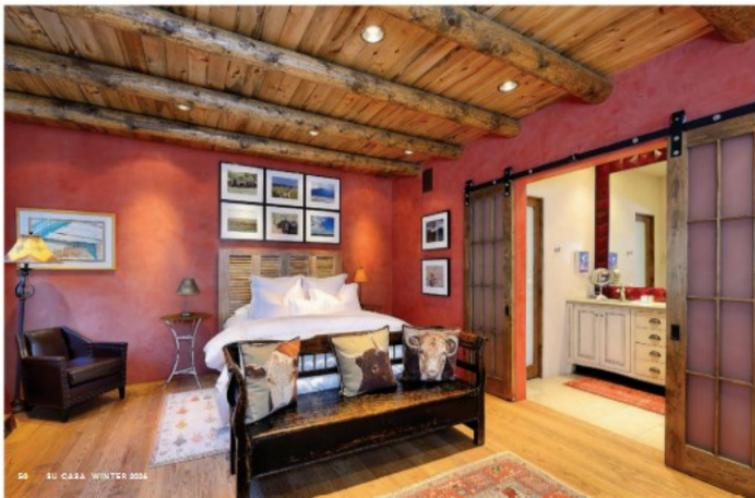
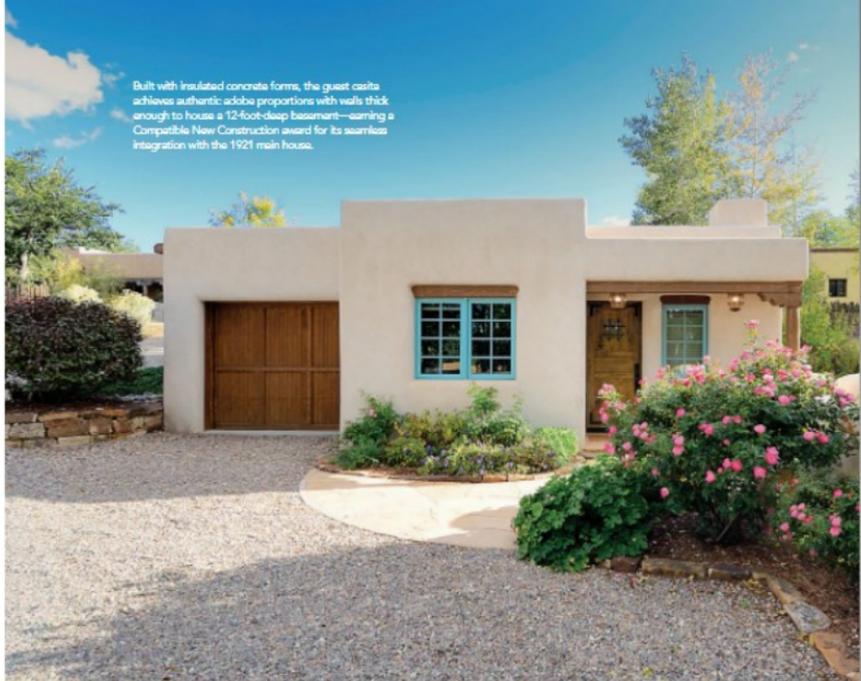
Built with insulated concrete forms, the guest casita achieves authentic adobe proportions with walls thick enough to house a 12-foot-deep basement—earning a Compatible New Construction award for its seamless integration with the 1921 main house.

While preservation guided the main house, the homeowners needed more space. A new casita, built right on the property line, provided a solution. Constructed with insulated concrete forms, the structure achieved adobe-like wall thickness while allowing for a 12-foot-deep basement—something impossible with traditional adobe construction.
